# REDMARLEY VILLAGE HALL FIRE RISK ASSESSMENT

# REDMARLEY VILLAGE HALL FIRE RISK ASSESSMENT INTRODUCTION

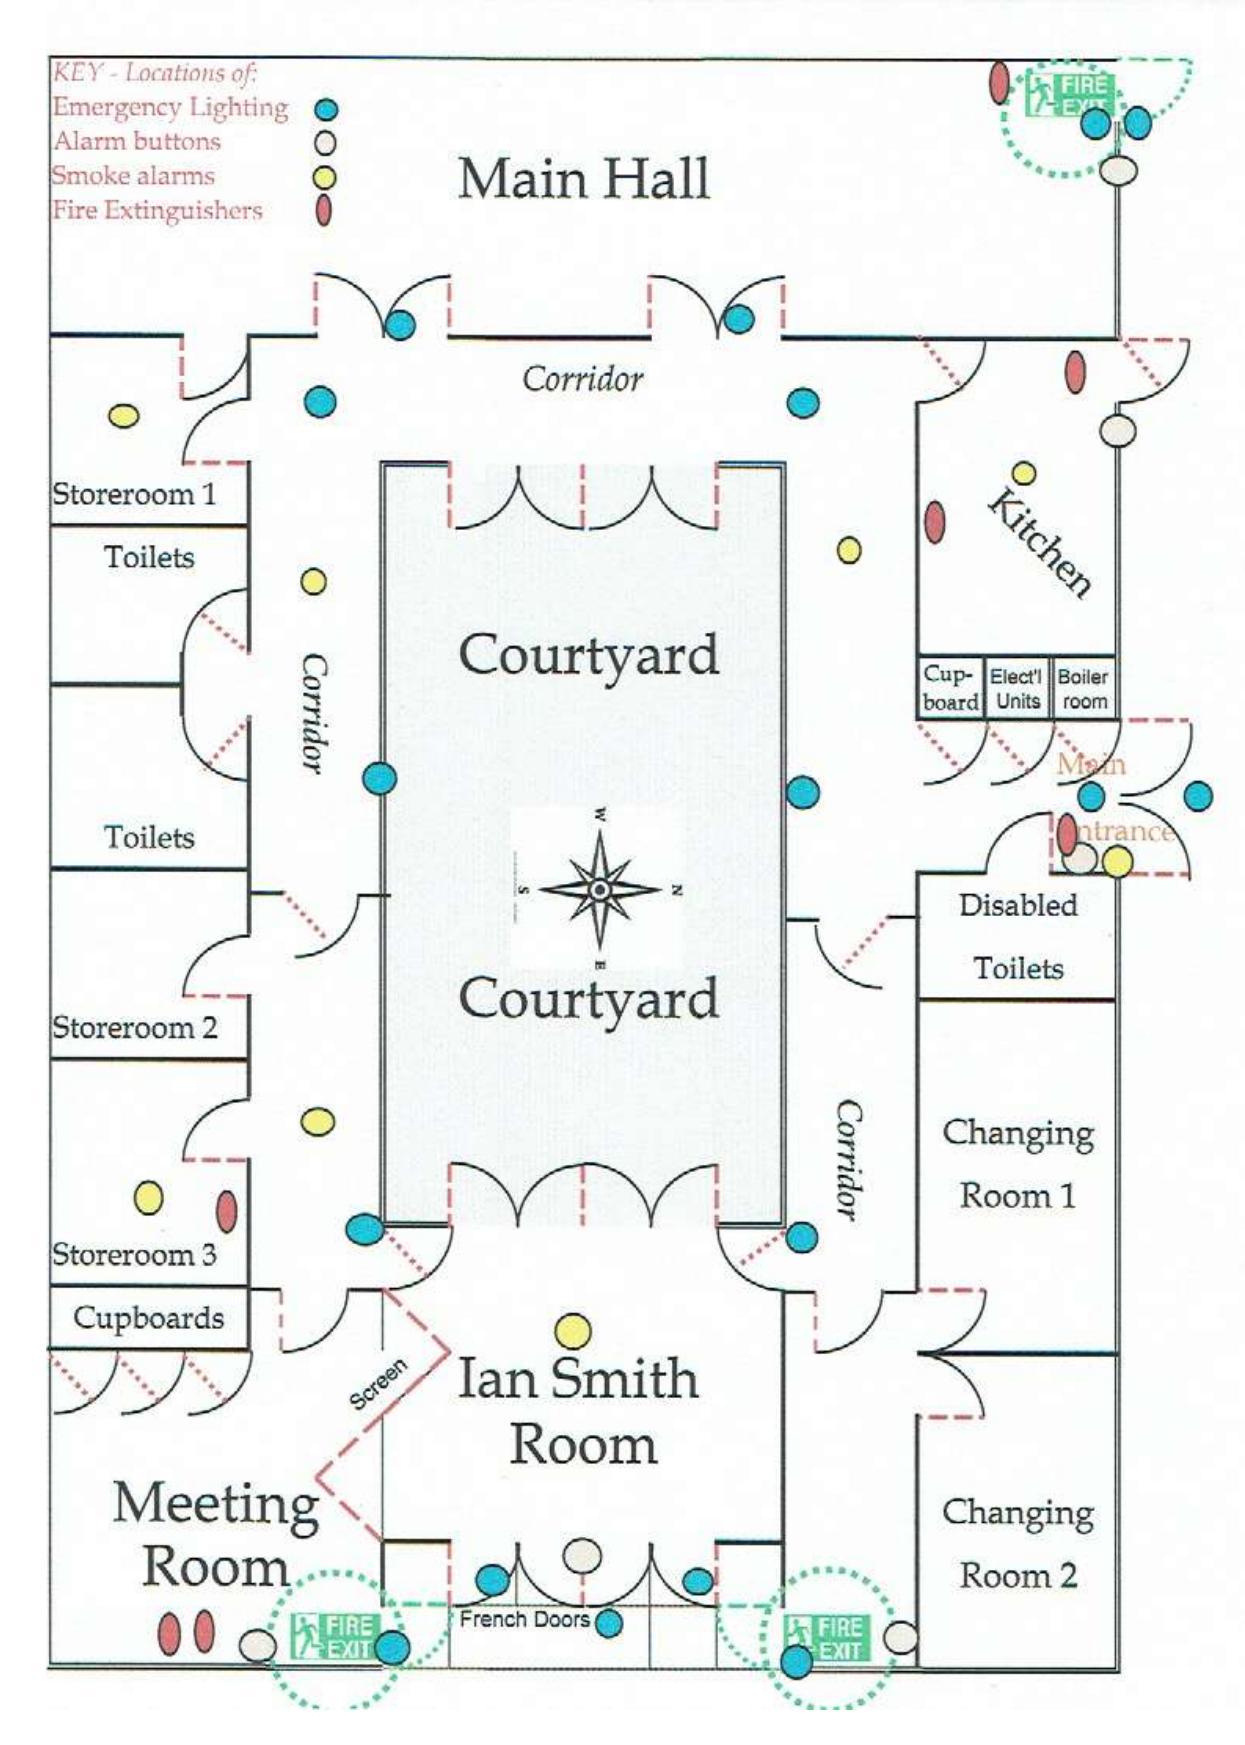
# PLAN OF REDMARLEY VILLAGE HALL (not to scale) APPENDIX I

All are independent of each other. The main escape routes are (1) the main entrance (2) an external fire door off the main hall (3) external fire doors located in the Ian Smith room annexe (4) corridor next to the changing rooms.
